G151

TITLE: RUBBER IMPELLER PUMP
MATERIAL: SEE DETAILS
DWG NO: G151

G Series Technical Guide – 15000 Impeller

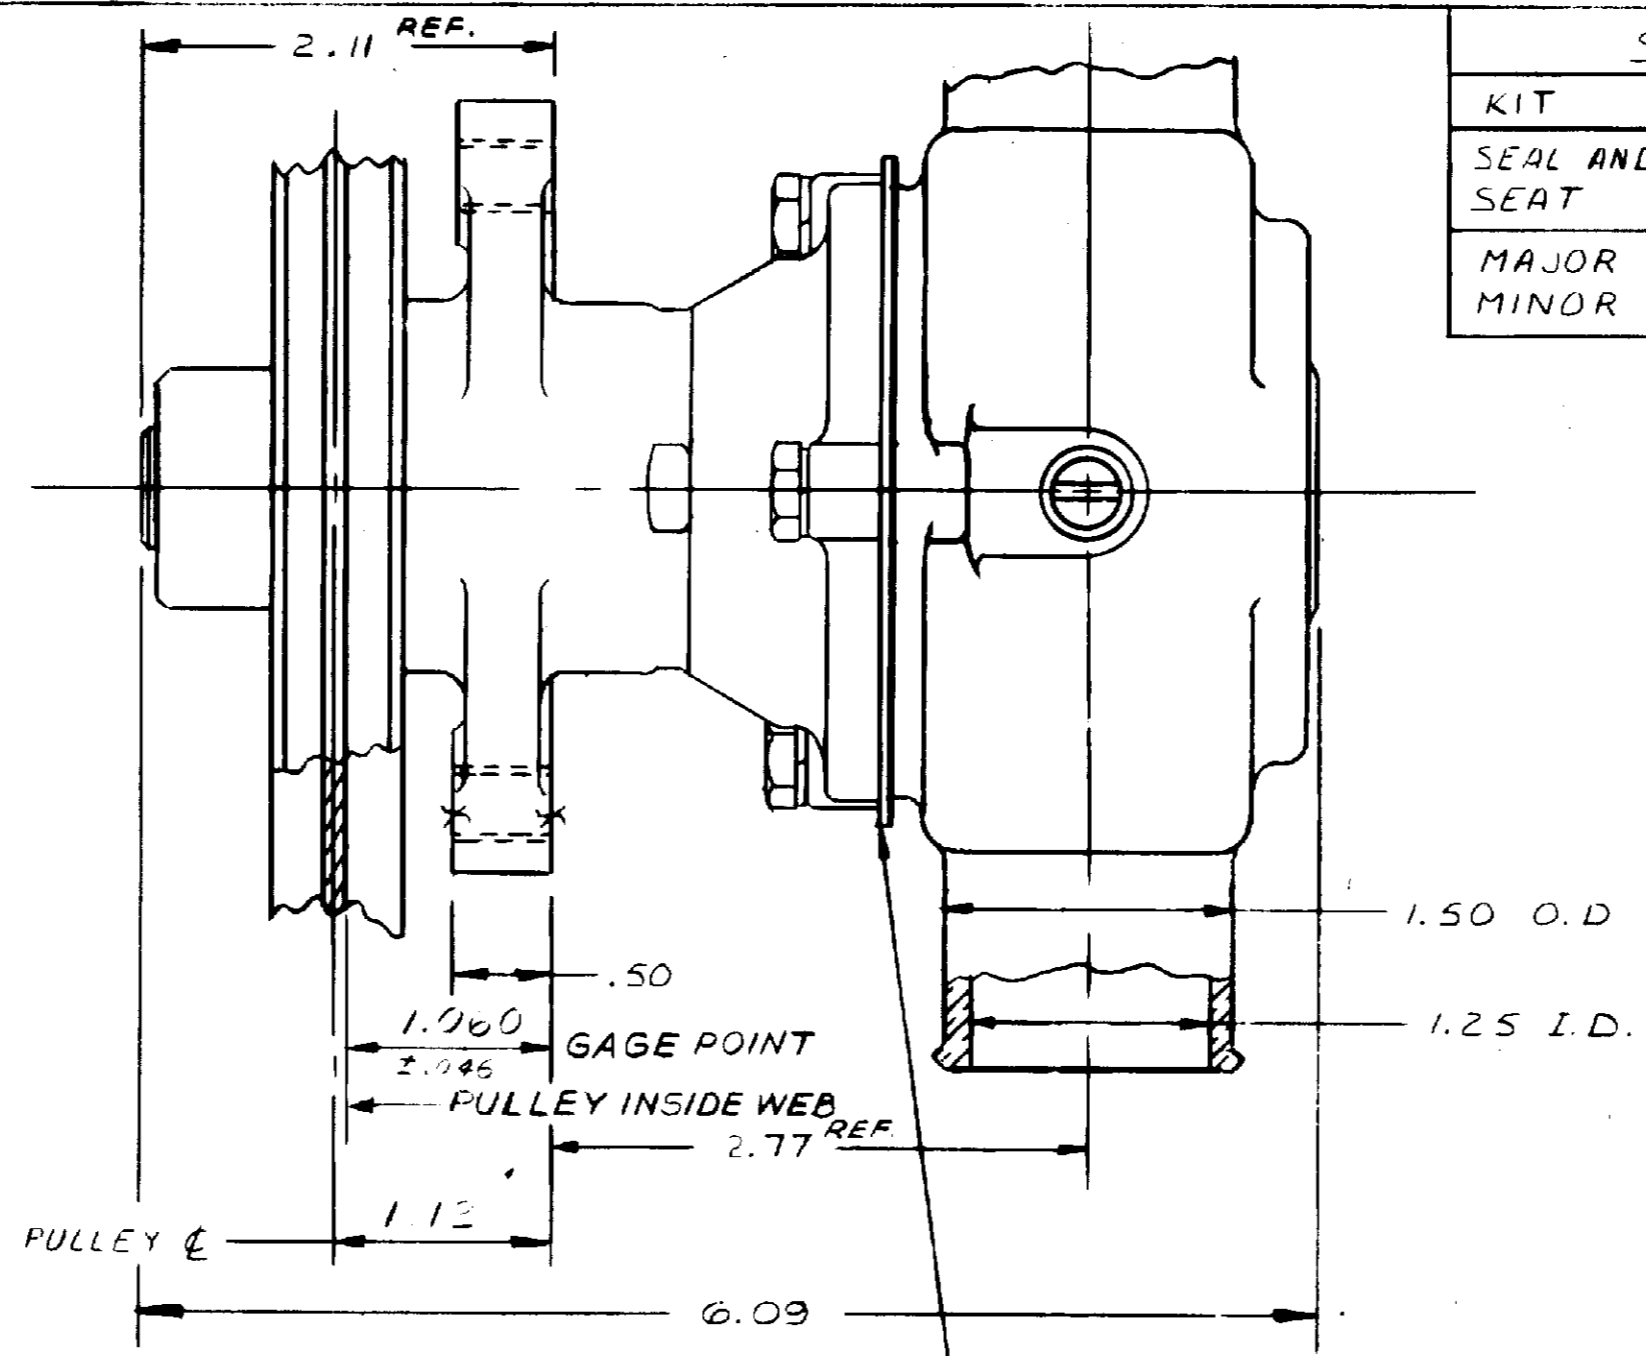
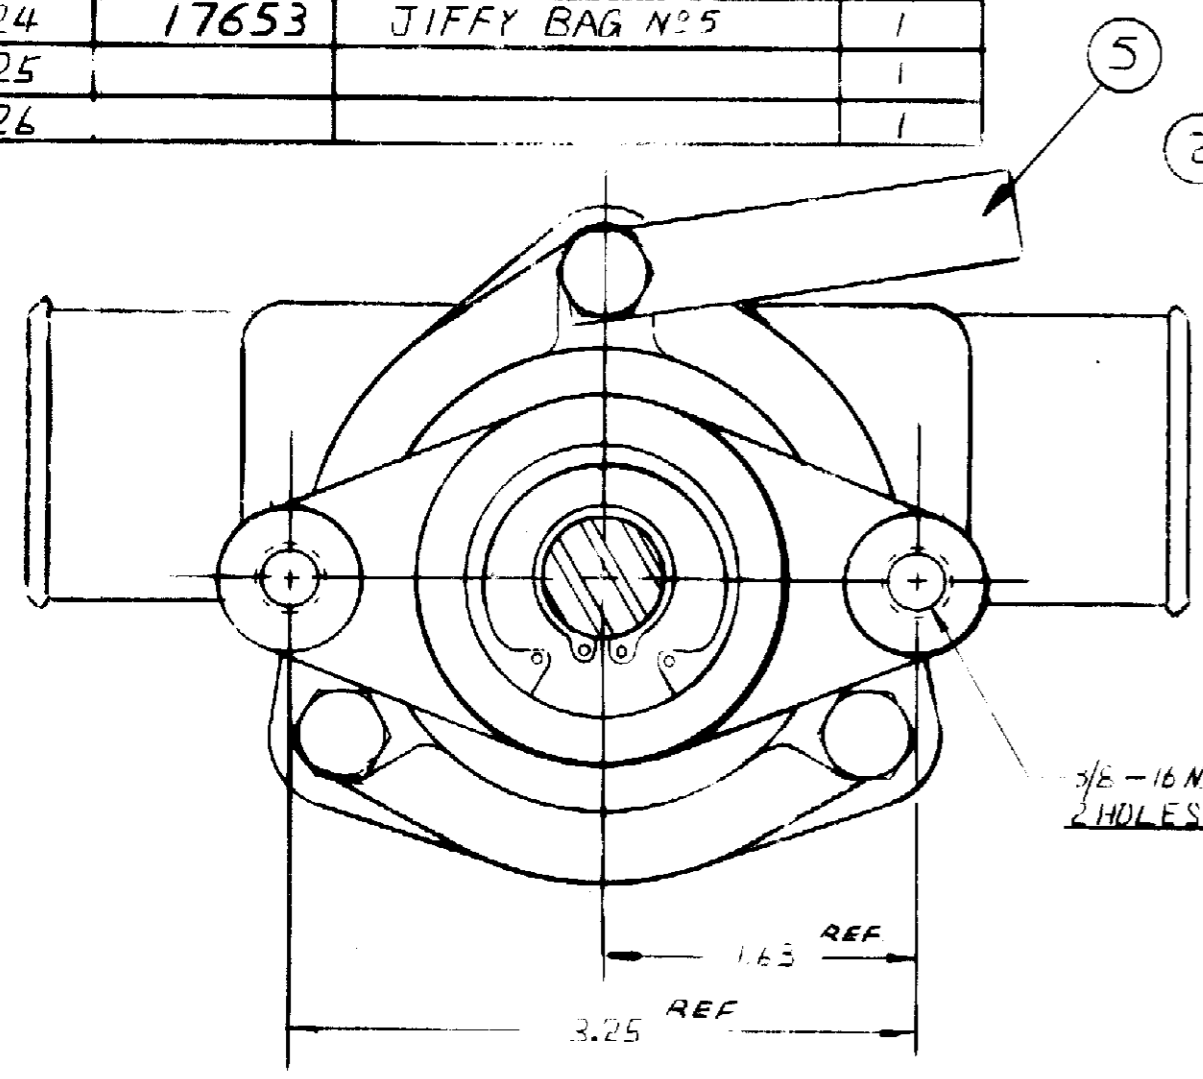
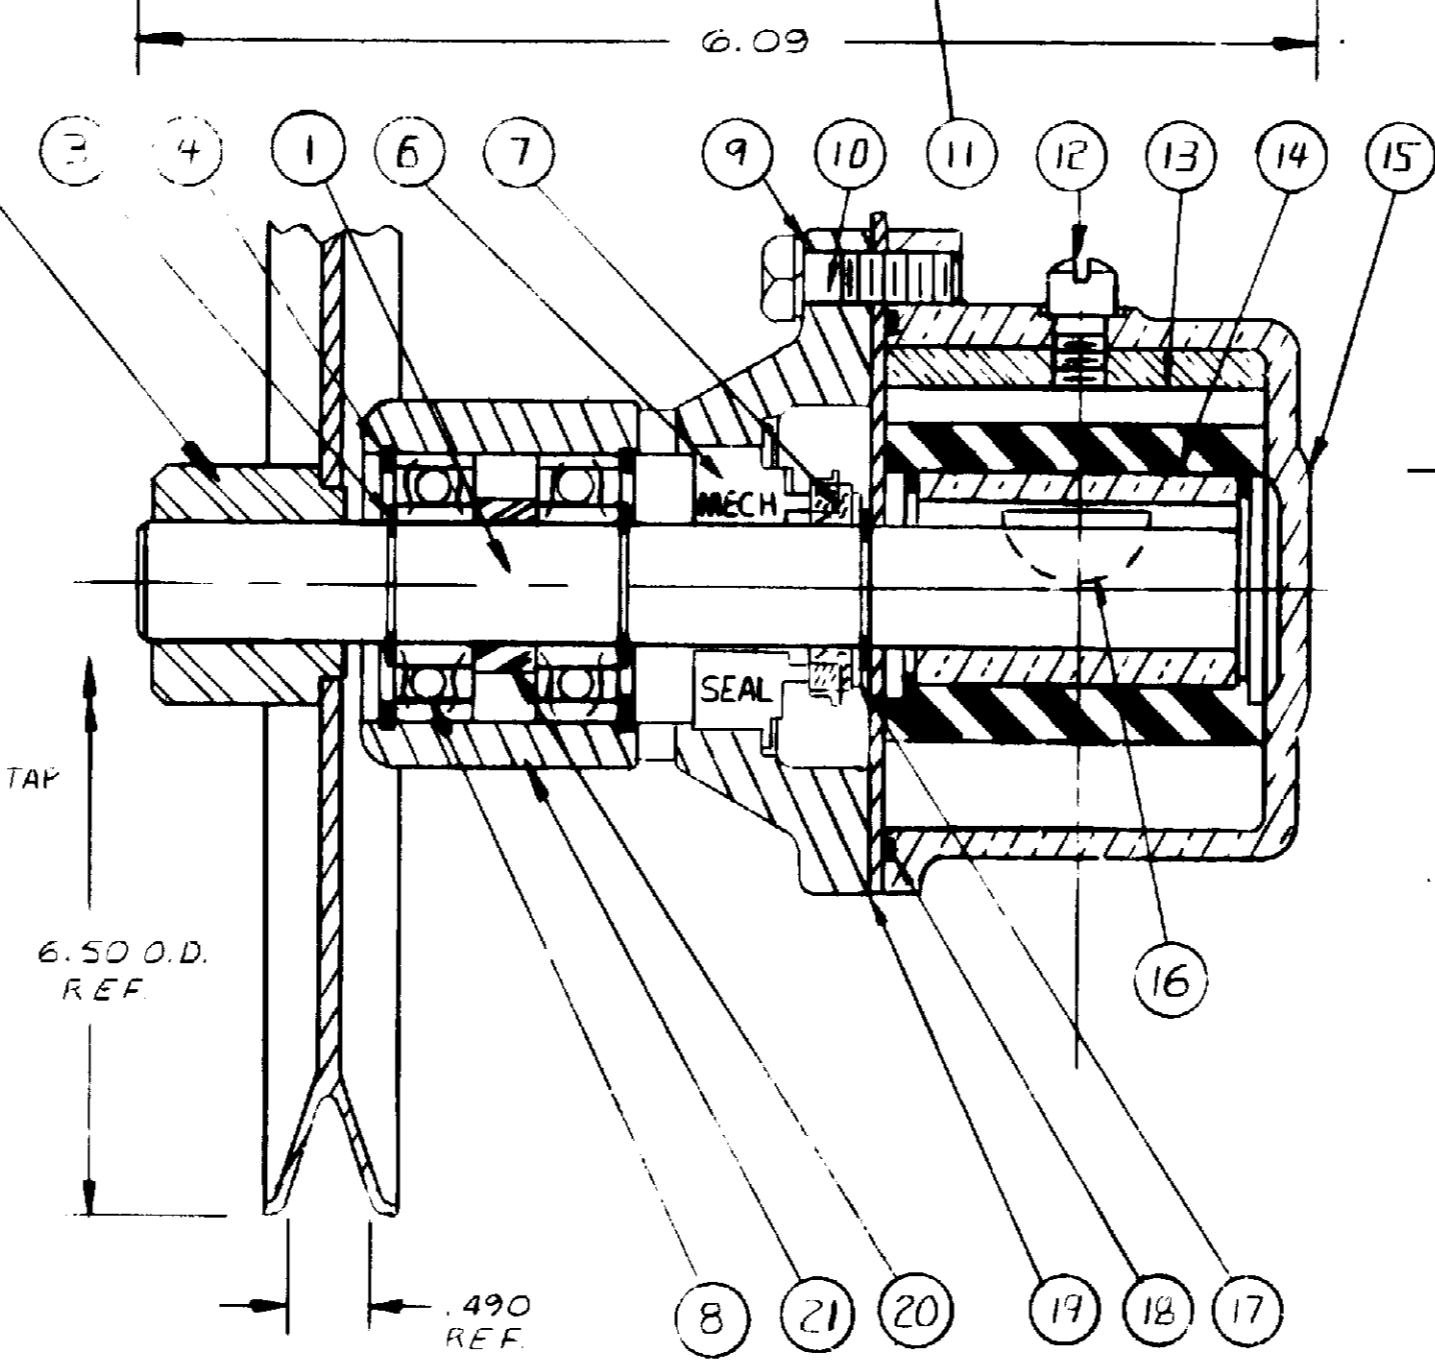
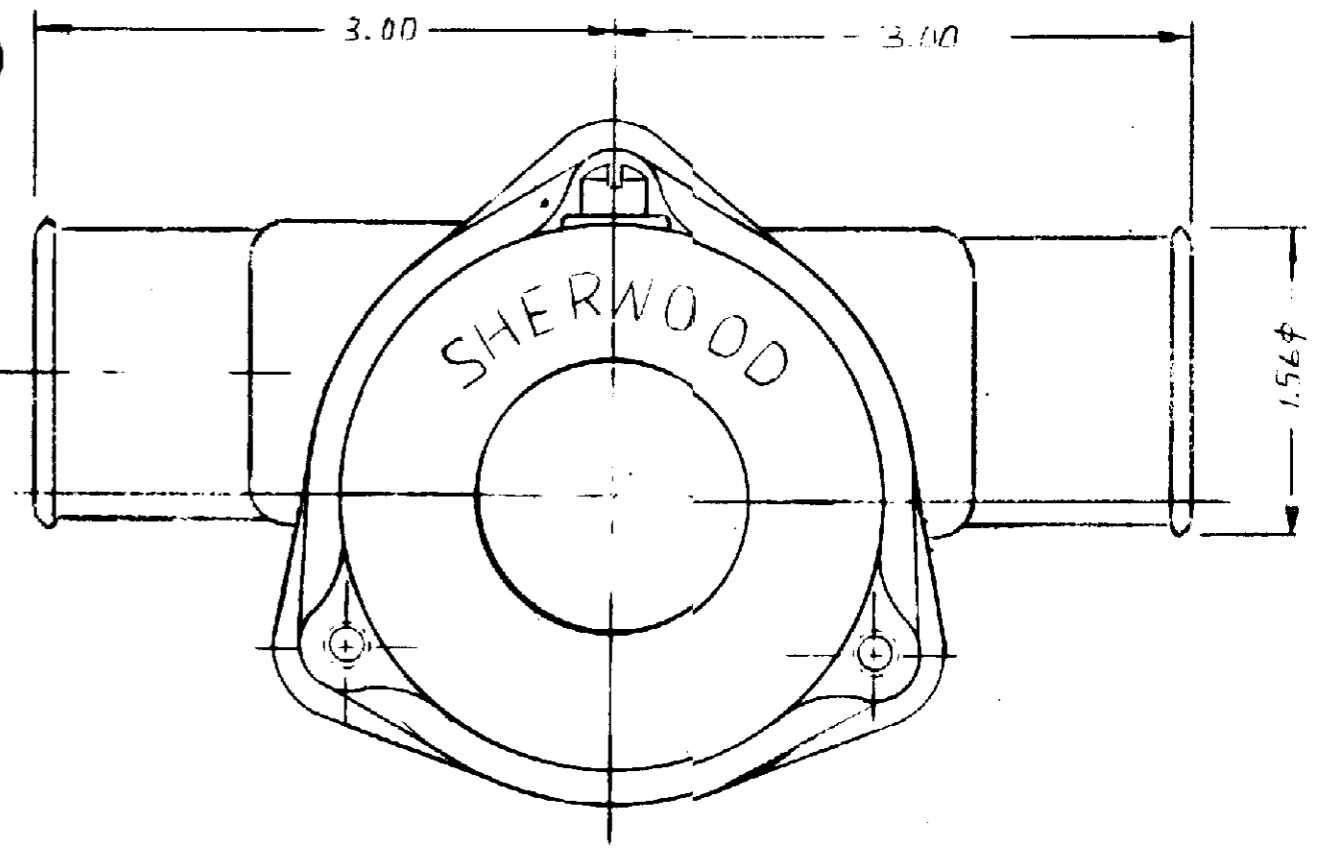
STAMP MODEL N.º; DATE CODE JN
Nº13285 TAG AND ATTACH AS SHOWN

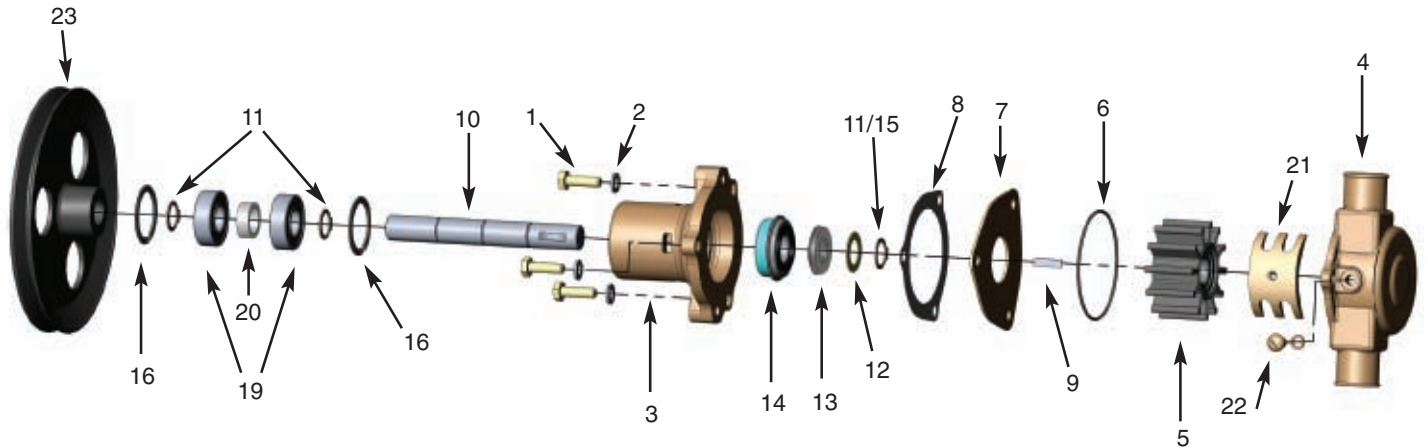
Assembly / Disassembly Instructions

The following assembly/disassembly procedures apply to all G Series pumps. Deviations from pump to pump are primarily a result of different methods of drive and mounting.

- A. Remove the screws (1) and lockwashers (2) that hold the body (3) and housing (4) together.
- B. The housing assembly including the impeller (5) can be removed from the body assembly, along with the o-ring (6), spacer plate (7) and gasket (8).

- G. Remove the large internal retaining ring (16) from the body at the end of the bearing.
- H. Support the body, and press the shaft, bearings (19), spacer (20) and retaining rings (11) out through the bearing or pulley end of the body.

- I. The seal assembly (14) is pressed into the body. It can be removed by pushing a tool through the bearing end and up against the metal or back side of the seal. **Note:** On some pumps, there is a spacer located between the pulley (hub) and bearing on the shaft. On other pumps, the bearings are positioned on the shaft with a retaining ring on each end. Support the bearings on the inner race, and push the shaft out of the bearings.

- B. Assemble a retaining ring (11) on the shaft into the second groove from the impeller end. Push the ball bearing (19) over the shaft (10). Press on the inner race of the bearing. Push the bearing up against the retaining ring. (Push the bearing on from the pulley or drive end, except for M71, GC1, GC4 and GC5 pumps). Assemble a spacer and then the second ball bearing. Assemble the second retaining ring over the shaft and up against the ball bearing, if required.

- D. Press the mechanical seal (14) into the body from the impeller end. Make sure that seal is pressed in square. A tool should be used to assure proper assembly.

- E. Push the bearing and shaft assembly into the body using care not to cock the bearing. A tool is recommended that will give you uniform pressure on the bearing outer race. Lock the bearing in place with the large internal retaining ring.

- F. Assemble the seat assembly (13), shoulder washer (12) and retaining ring (11 or 15) over the shaft from the impeller end. Locate the white ceramic surface against the seal – Do not damage (scratch) the white ceramic surface of the seat, or the seal and seat assembly might leak. Lubricate the rubber part of the seat and use a tool for ease of assembly.

- H. While supporting the shaft, press the pulley/gear (23) or hub (24) onto the shaft. Secure pulley/hub with pin (17) or key (18) and retaining ring or setscrew as needed.
- I. Press the woodruff key (9) into the shaft. Make sure the stainless steel key is used at this location.
- J. Assemble the impeller (5) into the housing (4). **Note:** Do not use petroleum-based fluid to lubricate the impeller.
- K. Place the o-ring (6) in the groove in the housing (4). A small dab of grease will help hold it in position until the housing to body screws are tightened. Assemble the gasket (8) and spacer plate (7) on the body (3), and line up the screw holes.
- L. Replace the lockwashers (20) and tighten the screws (1). Torque the screws to 84 in.-lbs.
- M. After installation, inspect the pump seal, lip seal, body, housing and cam areas for leaks.

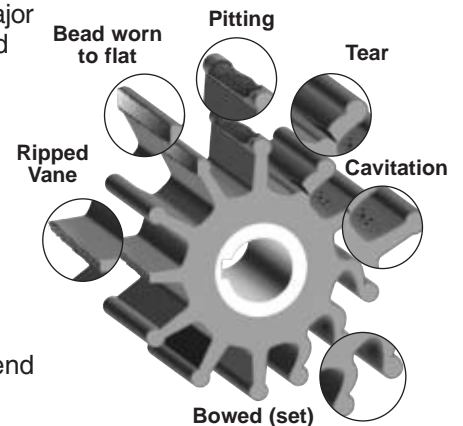
- ImpellerInspect for cracks or tears. Also, inspect for excessive abrasion of vane ends. Replace annually, or if any of the conditions exist, as in the picture. (See maintenance schedule on back page.)
